White Cloud

built 1912 by Gann & Palmer, Teignmouth

A roughly chronological record of the restoration.

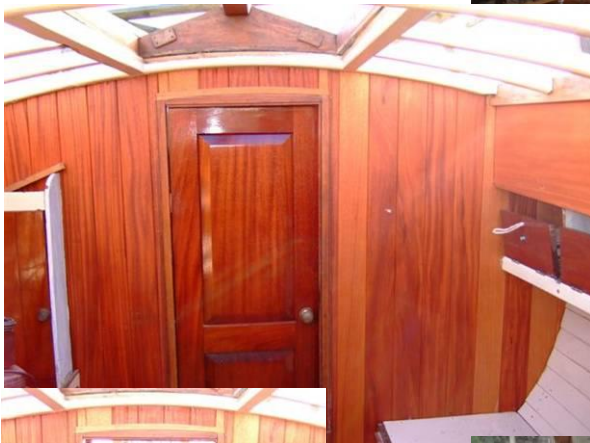
Old stem post removed, new post laminated and fitted with new bronze studs.
Old breasthook 'exploded' by rusting stem bolt. New breasthook.

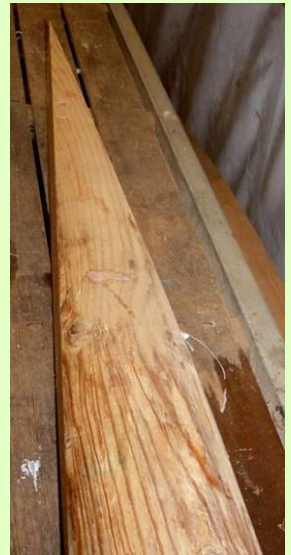
Forming the 'male' splice on the original, broken, mast; sawing & rough chiselling then planing in the 1:12 splicing box. The mast is then carefully rotated through 180° & the process repeated.

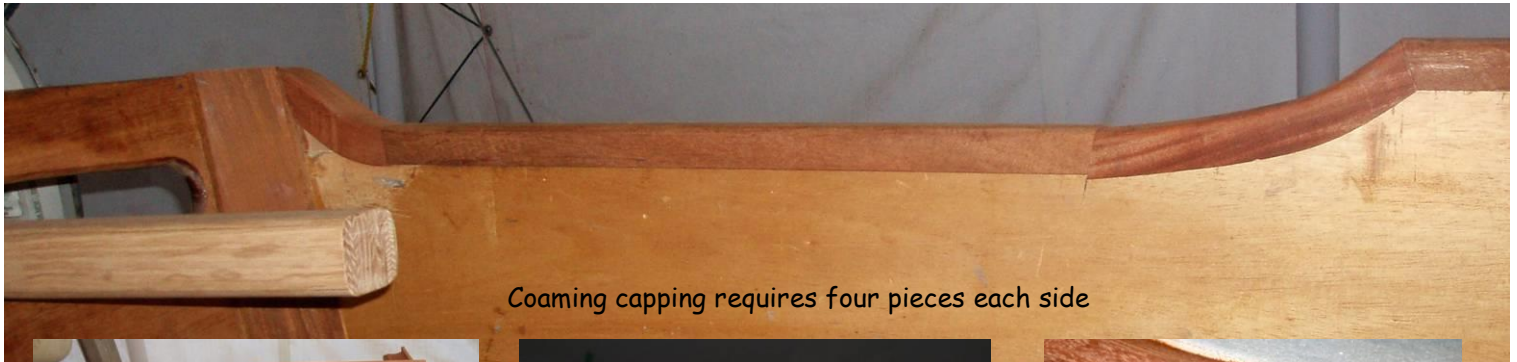
Finished male splice

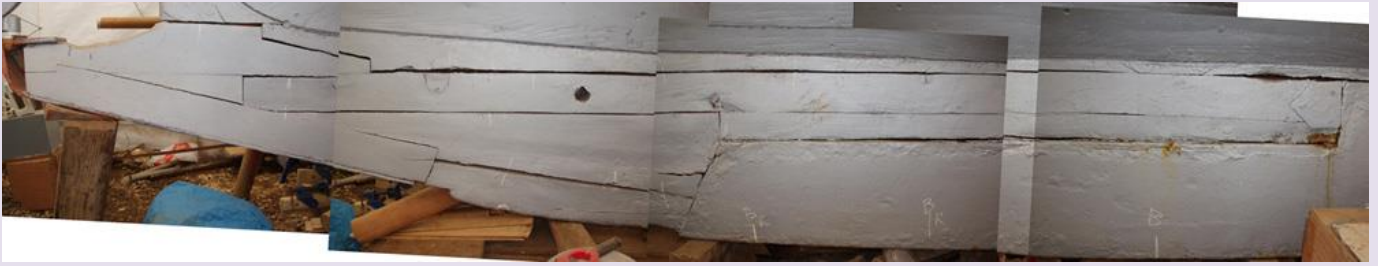
A composite showing the keel timbers that need to be replaced with new oak.

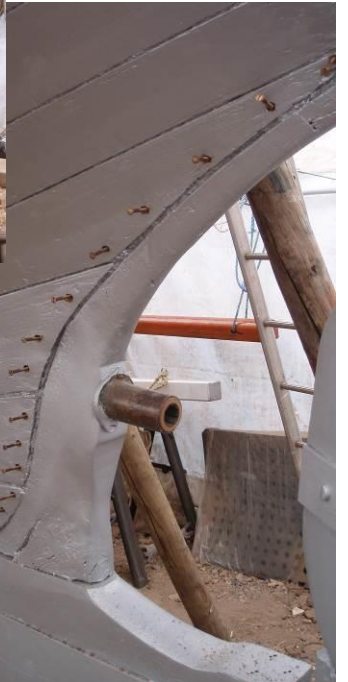
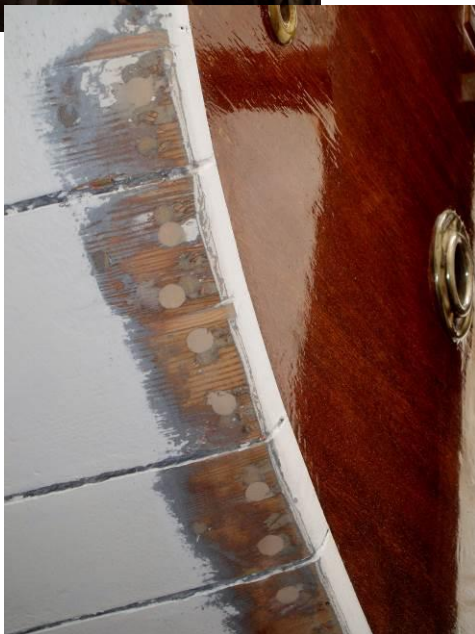
The surveyor recommended that the hood end and garboard fixings are doubled-up to ensure as little movement as possible. 170, 1 $\frac{3}{4}$ " No.10, bronze screws are inserted!
